Lessons Learned from Platform (Mezzanine) Installations:

Providing Fast-Turnaround Workspace and Inventory Solutions

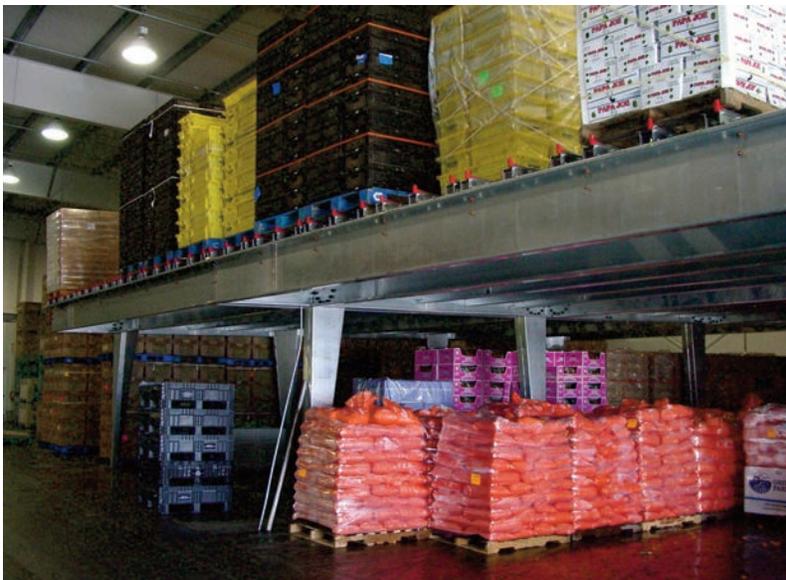
Working under a tight three-week production deadline, a 14,000 sq. ft. custom wide-span platform (mezzanine) was designed and built over the facility's existing dock area with compliance to code and clearance requirements. The platform (mezzanine) span had to correlate with the building's column span of 44' and handle a load of 150 Psi.

To ensure public safety and uninterrupted customer service, the 44' span platform (mezzanine) was installed during the 3rd shift. The finished structure added 14,000 SF of floor space over the existing loading docks of the warehouse. The platform (mezzanine) was equipped with efficient storage and order picking with a high-speed conveying system.
